DEPARTMENT OF TRANSPORTATION

Quality Assurance and Source Inspection

Contract #: 04-0120F4Cty: SF/ALA Rte: 80 PM: 13.2/13.9File #: 69.28**WELDING INSPECTION REPORT****Resident Engineer:** Pursell, Gary**Address:** 333 Burma Road**City:** Oakland, CA 94607**Report No:** WIR-000356**Date Inspected:** 11-Aug-2007**Project Name:** SAS Superstructure**OSM Arrival Time:** 800**Prime Contractor:** American Bridge/Fluor Enterprises, a JV**OSM Departure Time:** 1730**Contractor:** Zhenhua Port Machinery Company, Ltd (ZPMC), Changxing Island **Location:** Shanghai, China**CWI Name:** Huang Wei**CWI Present:** Yes No**Inspected CWI report:** Yes No N/A**Rod Oven in Use:** Yes No N/A**Electrode to specification:** Yes No N/A**Weld Procedures Followed:** Yes No N/A**Qualified Welders:** Yes No N/A**Verified Joint Fit-up:** Yes No N/A**Approved Drawings:** Yes No N/A**Approved WPS:** Yes No N/A**Delayed / Cancelled:** Yes No N/A**Bridge No:** 34-0006**Component:** PQR**Summary of Items Observed:**

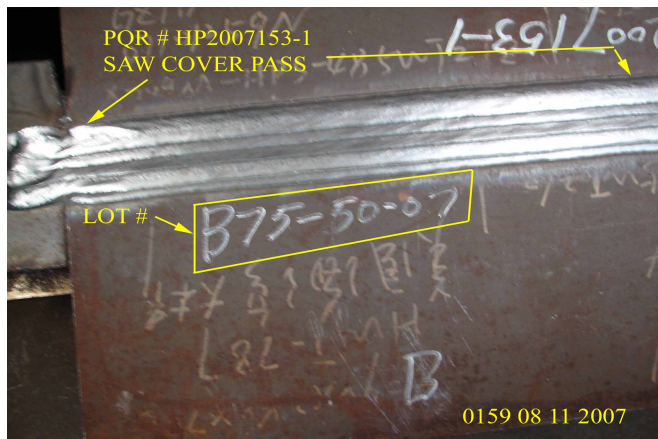
Caltrans Quality Assurance (QA) Inspector Chuck Franco was present at the time requested to randomly observe welding being performed on a Procedure Qualification Record (PQR). The welding is being attempted with the submerged arc welding (SAW) process in the 1G or flat groove position. The PQR weld joint is a single V groove with a 20 degree included groove angle, a 16 millimeter root opening with a 20 millimeter thick by 200 millimeter wide steel backing strip. The QA Inspector observed ZPMC CWI Huang Wei monitoring preheat, welding amperage and welding voltage. Mr. Wei was being assisted by Fu Jun of the ZPMC Technological Department, who was monitoring travel speed and recording all weld parameters. The QA Inspector also performed random verification of the above weld parameters and documented same. The attached photograph provides additional detail.
